Regal® Flushometer

NOTE: Also for use with Regal® XL
(Since mid-2010)

The repair kits and parts listed on this page are designed to service all Sloan diaphragm type flushometers, including those manufactured for low consumption (LC) usage.

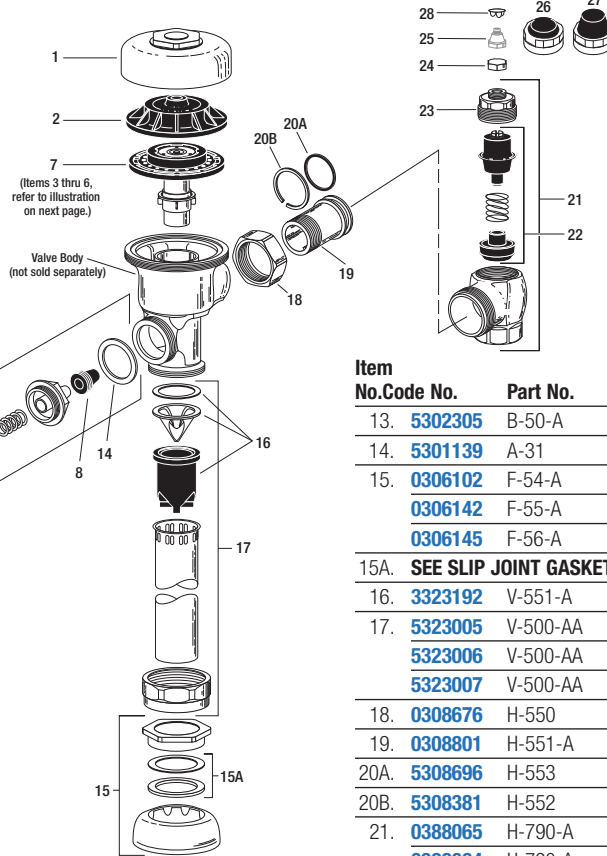
PARTS LIST

Item No.	Code No.	Part No.	Description
1.	0317004	R-10	CP Cover
	—	R-10-HE	CP High Efficiency Cover
2.	0301168	A-71	Inside Cover
SEE ITEMS 3A THROUGH 6E IN CHART ON NEXT PAGE			
3A.	5301058	A-19-AC	Relief Valve, White (Closet) – 12 per package
3B.	5301059	A-19-AU	Relief Valve, Black (Urinal) – 12 per package
3C.	5301211	A-19-ALC	Relief Valve, Green (Closet/Urinal-LC) – 12 per package
3D.	0301143	A-19-AL	Relief Valve, Blue (9 Liter Closet) – 12 per package

4.	5301111	A-15-A	Disc – for all Inside Parts Kits – 12 per package
5.	5301188	A-156-A	Diaphragm – for all Inside Parts Kits – 12 per package
6A.	5301236	A-163-A	Guide Assembly 4.5 gpf/17.0 Lpf Closet & 1.5 gpf/5.7 Lpf Urinal – 12 per package
6B.	5301032	A-152-A	Guide Assembly 3.5 gpf/13.2 Lpf Closet – 12 per package
6C.	5301031	A-151-A	Guide Assembly 1.6 gpf/6.0 Lpf LC Closet – 12 per package
6D.	5301155	A-155-A	Guide Assembly 1.0 gpf/3.8 Lpf LC Urinal – 12 per package
6E.	5301157	A-157-A	Guide Assembly 0.5 gpf/1.9 Lpf Urinal – 12 per package

7.	SEE INSIDE PARTS KITS CHART ON NEXT PAGE		
8.	5302297	B-39	Seal – 12 per package
9.	5302279	B-32-A	CP Handle Assembly – 6 per package
	0302390	B-73-A	CP Handicap Handle Assembly (ADA Compliant)

10.	0301082	A-6	CP Handle Coupling
11.	0302109	B-7-A	CP Socket Assembly
12.	5302274	B-32	CP Handle Grip – 12 per package
	0302389	B-74-A	CP Handicap Handle Grip (ADA Compliant)

Item No.	Code No.	Part No.	Description
13.	5302305	B-50-A	Handle Repair Kit – 6 per package
14.	5301139	A-31	Handle Gasket – 48 per package
15.	0306102	F-54-A	3/4" CP Spud Coupling Assembly
	0306142	F-55-A	1-1/4" CP Spud Coupling Assembly
	0306145	F-56-A	1-1/2" CP Spud Coupling Assembly
15A.	SEE SLIP JOINT GASKETS AND RINGS TABLE BELOW

16.	3323192	V-551-A	Vacuum Breaker Repair Kit
17.	5323005	V-500-AA	3/4" x 9" CP Vacuum Breaker – 6 per package
	5323006	V-500-AA	1-1/4" x 9" CP Vacuum Breaker – 6 per package
	5323007	V-500-AA	1-1/2" x 9" CP Vacuum Breaker – 6 per package

18.	0308676	H-550	CP Stop Coupling †
19.	0308801	H-551-A	CP Adjustable Tailpiece 2-1/16" long †
20A.	5308696	H-553	O-ring – 24 per package
20B.	5308381	H-552	Locking ring – 12 per package

21.	0388065	H-790-A	1" Screwdriver Bak-Chek® Stop CP – complete
	0388064	H-790-A	3/4" Screwdriver Bak-Chek® Stop CP – complete
	0388029	H-740-A	1" Screwdriver Bak-Chek® Stop CP – OBsolete
	0388031	H-740-A	3/4" Screwdriver Bak-Chek® Stop CP – OBsolete

22.	3308853	H-541-ASD	1" Control Stop Repair Kit *
	3308856	H-543-ASD	3/4" Control Stop Repair Kit **
23.	0308612	H-622	CP Bonnet (Current Regal)
	0308991	H-639	CP Bonnet – Pre 2010 Regal Stops*
	0308601	H-538	CP Bonnet ** – OBsolete

24.	5388001	H-1012-A	CP Cap – 6 per package VP
25.	5310034	J-2/J-7	Bumper Assembly – 6 per package – OBsolete
26.	3308866	H-574	Stop Cap, chrome plated with Seat Bumper (-YO)

27.	3308867	H-576	Stop Cap, chrome plated with Extended Seat Bumper (-YG)
28.	5388002	H-528	Hole Plug

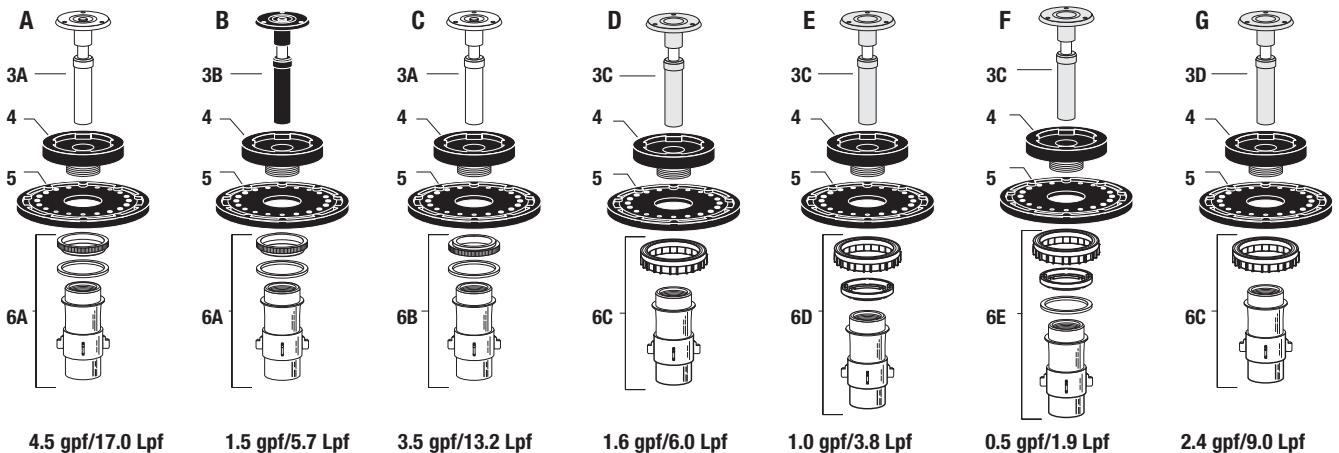
ITEM 7. INSIDE PARTS KITS (SEE ILLUSTRATIONS BELOW)

Item No.	Code No.	Part No.	Application
A.	3301036	A-36-A	4.5 gpf/17.0 Lpf - Closet
B.	3301037	A-37-A	1.5 gpf/5.7 Lpf - Urinal
C.	3301038	A-38-A	3.5 gpf/13.2 Lpf - Closet
D.	3301041	A-41-A	1.6 gpf/6.0 Lpf - Closet
E.	3301044	A-42-A	1.0 gpf/3.8 Lpf - Urinal
F.	3301081	A-43-A	0.5 gpf/1.9 Lpf - Urinal
G.	3301024	A-44-A	2.4 gpf/9.0 Lpf - Closet

ITEM 7. INSIDE PARTS COMPONENTS (SEE ILLUSTRATIONS BELOW)

Item No.	Code No.	Part No.	Description
3A.	5301058	A-19-AC	Relief Valve, White (Closet) – 12 per pkg.
3B.	5301059	A-19-AU	Relief Valve, Black (Urinal) – 12 per pkg.
3C.	5301211	A-19-ALC	Relief Valve, Green (Closet/Urinal-LC) – 12 per pkg.
3D.	0301143	A-19-AL	Relief Valve, Blue (9 Liter Closet) – 12 per pkg.
4.	5301111	A-15-A	Disc – for all Inside Parts Kits – 12 per pkg.
5.	5301188	A-156-A	Diaphragm – for all Inside Parts Kits – 12 per pkg.
6A.	5301236	A-163-A	Guide Assembly 4.5 gpf/17.0 Lpf Closet & 1.5 gpf/5.7 Lpf Urinal – 12 per package
6B.	5301032	A-152-A	Guide Assembly 3.5 gpf/13.2 Lpf Closet – 12 per package
6C.	5301031	A-151-A	Guide Assembly 1.6 gpf/6.0 Lpf LC Closet – 12 per package
6D.	5301155	A-155-A	Guide Assembly 1.0 gpf/3.8 Lpf LC Urinal – 12 per package
6E.	5301157	A-157-A	Guide Assembly 0.5 gpf/1.9 Lpf Urinal – 12 per package
