# Gem•2® Flushometer

Manual Flushometers

### PARTS LIST

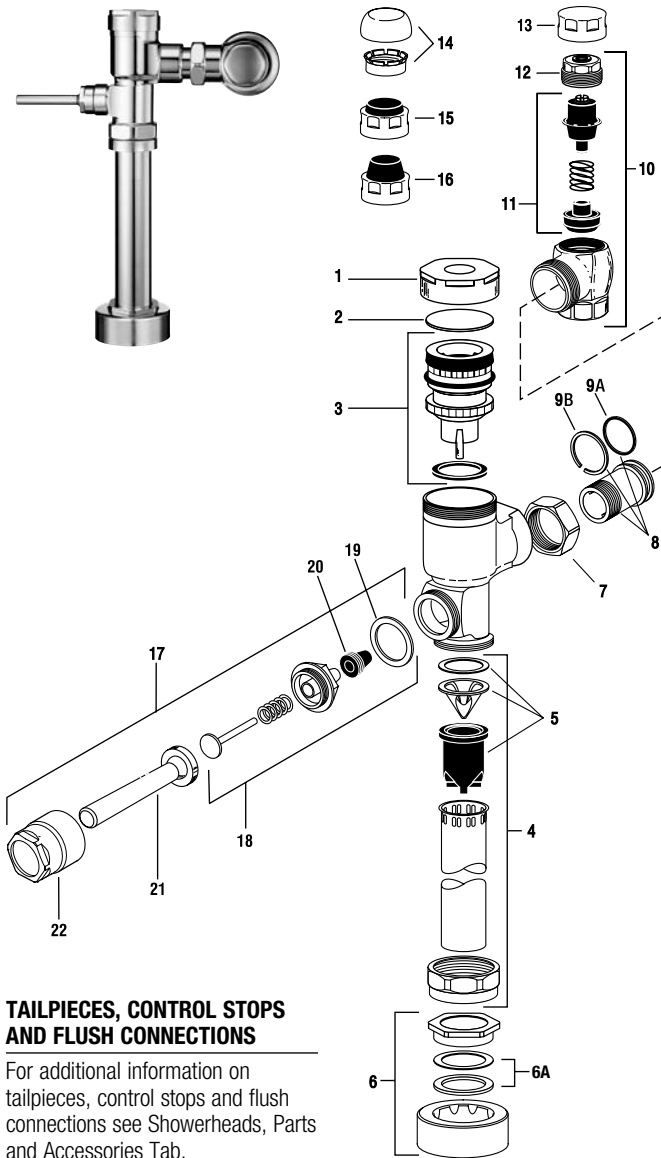
Item No.	Code No.	Part No.	Description
1.	<a href="#">0307142</a>	G-105	CP Cover
2.	<a href="#">0307139</a>	G-106	Slip Disc
3.	<a href="#">3307135</a>	G-1022-A	Piston Kit – 1.28 gpf/4.8 Lpf Water Closet
	<a href="#">0307193</a>	G-1007-A	Piston Kit – 3.5 gpf/13.2 Lpf Water Closet
	<a href="#">0307195</a>	G-1016-A	Piston Kit – 1.6 gpf/6 Lpf Water Closet
	<a href="#">0307192</a>	G-1009-A	Piston Kit – 1.5 gpf/5.7 Lpf Urinal
	<a href="#">0307185</a>	G-1017-A	Piston Kit – 1.0 gpf/3.8 Lpf Urinal
	<a href="#">3307133</a>	G-1018-A	Piston Kit – 0.5 gpf/1.9 Lpf Urinal
	<a href="#">3307134</a>	G-1019-A	Piston Kit – 2.4 gpf/9.0 Lpf Water Closet

4.	<a href="#">5323005</a>	V-500-AA	3/4" x 9" Vacuum Breaker – 6 per package
	<a href="#">5323006</a>	V-500-AA	1-1/4" x 9" Vacuum Breaker – 6 per package
	<a href="#">5323007</a>	V-500-AA	1-1/2" x 9" Vacuum Breaker – 6 per package
5.	<a href="#">3323192</a>	V-551-A	Vacuum Breaker Repair Kit
6.	<a href="#">3332002</a>	CR-1010-A	1-1/2" (38 mm) Spud Coupling
	<a href="#">3332001</a>	CR-1009-A	1-1/4" (32 mm) Spud Coupling
	<a href="#">3332000</a>	CR-1008-A	3/4" (19 mm) Spud Coupling

7.	<a href="#">0308676</a>	H-550	Stop Coupling
8.	<a href="#">0308801</a>	H-551-A	Adjustable Tailpiece 2-1/16" (Standard Length)
9A.	<a href="#">5308696</a>	H-553	O-ring – 24 per package
9B.	<a href="#">5308381</a>	H-552	Locking ring – 12 per package

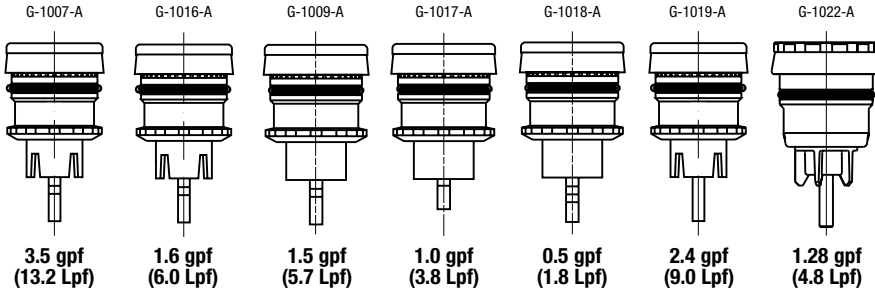
### ITEM 3. PISTON KITS

Code No.	Part No.	Description	Cover Color	Piston Color	Barrel	Grooves
<b>0307193</b>	G-1007-A	3.5 gpf (13.2 Lpf) – Water Closet	White	Gray	Slotted	2
<b>0307195</b>	G-1016-A	1.6 gpf (6.0 Lpf) – Water Closet	Green	Black	Slotted	2*
<b>0307192</b>	G-1009-A	1.5 gpf (5.7 Lpf) – Urinal	Black	Black	Solid	2
<b>0307185</b>	G-1017-A	1.0 gpf (3.8 Lpf) – Urinal	Yellow	Black	Solid	1
<b>3307133</b>	G-1018-A	0.5 gpf (1.8 Lpf) – Urinal	Red	Black	Solid	3
<b>3307134</b>	G-1019-A	2.4 gpf (9.0 Lpf) – Water Closet	Blue	Gray	Slotted	0
<b>3307135</b>	G-1022-A	1.28 gpf (4.8 Lpf) – Water Closet	Deep Purple	Black	Slotted	0

\*Prior to February 2006-1 Groove

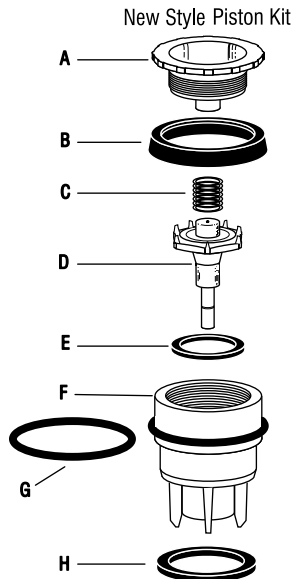
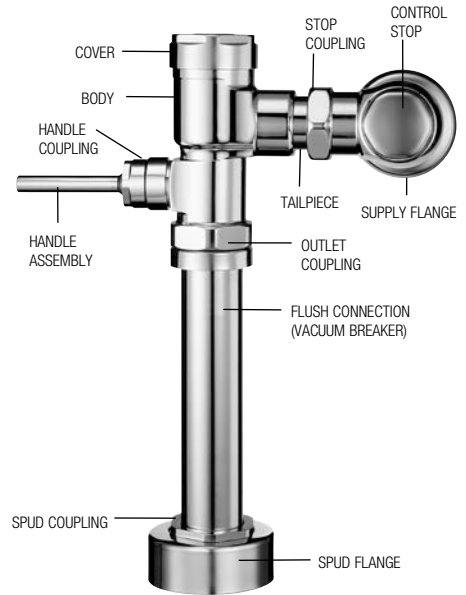
### ITEM 3. PISTON COMPONENTS

Item	Code No.	Part No.	Description
A.	***	***	Piston Cover
B.	<b>5307106</b>	G-78	Molded Cup – 12 per package
C.	<b>0307130</b>	G-102	Spring
D.	***	***	Relief Valve
E.	<b>0307116</b>	G-95	Relief Valve Seat
F.	***	***	Piston Body
G.	<b>0307210</b>	G-85	Filter O-ring
H.	<b>5307052</b>	G-21	Main Seat – 6 per package

Code No.	Part No.	Description
<b>3307128</b>	G-1011-A	Repair Kit includes Items: 2, 6, 7, B, C, E, G & H

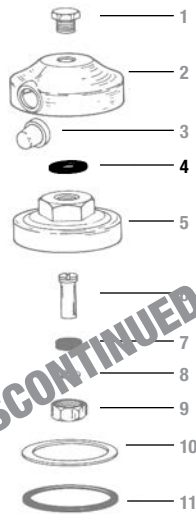
### REPAIR PARTS FOR OLD STYLE GEM FLUSHOMETERS (PRE-1985) Adjustable Cover

Item No.	Code No.	Part No.	Description
1.	—	G-24	CP Cover Screw – <b>OBSOLETE</b>
2.	—	G-23	CP Cover – <b>OBSOLETE</b>
	—	G-26	CP Cover for Bumper – <b>OBSOLETE</b>
3.	—	G-27	Bumper (12 per package) – <b>OBSOLETE</b>
4.	<b>0307058</b>	G-25	Cover Gasket (12 per package)
5.	—	G-4	RB Inside Cover – <b>OBSOLETE</b>
6.	—	G-6	RB Regular Screw – <b>OBSOLETE</b>
7.	—	S-26	Packing
8.	—	S-24	Packing Disc
9.	—	G-10	RB Packing Nut – <b>OBSOLETE</b>
10.	—	G-65	Gasket – <b>OBSOLETE</b>
11.	—	G-5	Gasket
